## **Case 1. A large rural block paving pressure washing and sealing example**

## **Case 2. Cleaning up after summer floods**

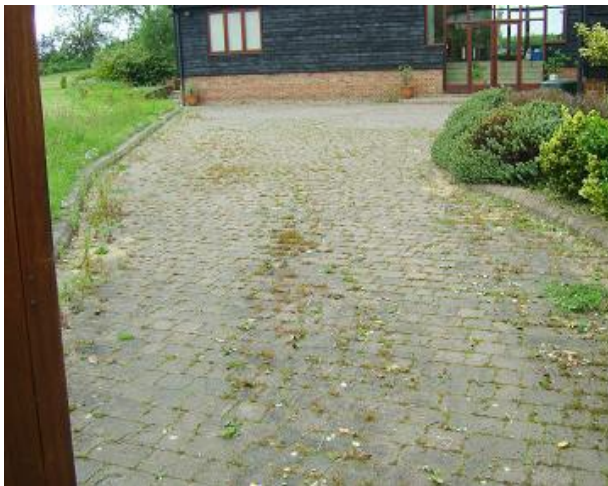
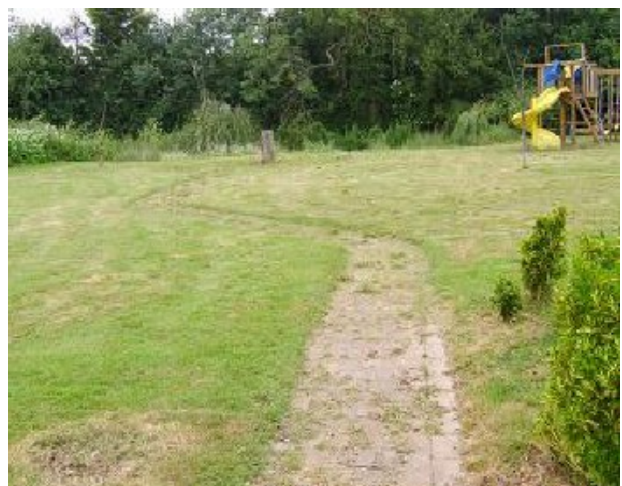
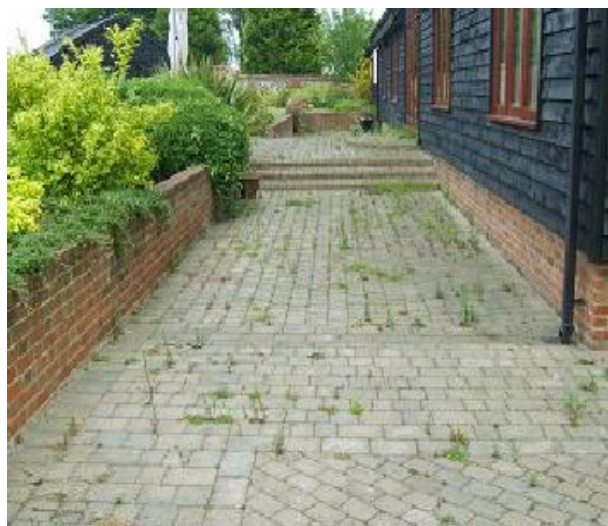
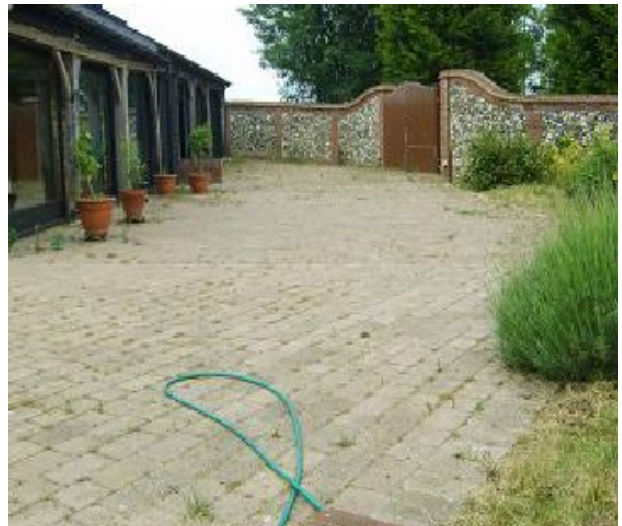
### **Site survey gallery**

The area of paving to be dealt with was measured and found to be 705 m<sup>2</sup>. Our analysis was that to bring all the paving up to the required standard would need a 3 part work programme. We recommended that due to the excessive and strong growth of the weeds, we must first apply a weed killer. For the application of the weed killer to have enough time to kill the roots it would be necessary to wait 2 weeks, after which we could pressure wash all the treated areas and clean up the debris. The final act of this proposed 3 part exercise would be to brush in fresh kiln dried sand into the joints in the paving and apply Seal a Block Commercial Pre-polymer Urethane sealant.

We explained to the client how the proposed sealant works and that it will set the sand hard in the joints, thus preventing further re-growth of weeds from the joints of the paving. We had determined that Seal a Block commercial was the only suitable sealant, because of the area to be covered, the initial strength of the weeds, and also the size of joints commonly associated with Tegula block paving. In addition using Seal a Block Commercial with its one coat application spread by a squeegee, we were sure we could achieve a consistent finish over the large areas involved. Seal a Block Commercial has been designed to work in the harshest of applications such as in

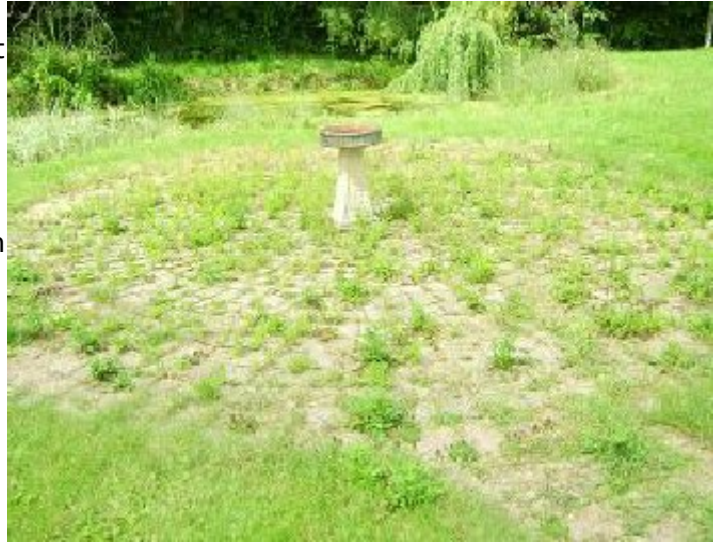
airport hard standings for aircraft. This made it ideal to handle the wider gaps of the Tegula paving, soaking into sand really well and setting it hard to the side of paver's but still retaining the flexural properties of the paving. The lower cost option of an Acrylic sealer would just not be good enough for this job, and would have been a penny-wise pound-foolish option, which we would not recommend. We further advised the client that some regular light maintenance would be required after we had done the job to keep it in good condition, if he decided to go ahead and accept our quotation for the work we had proposed.

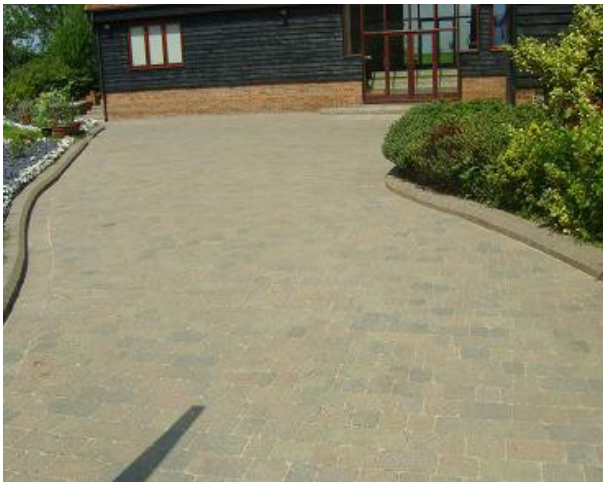
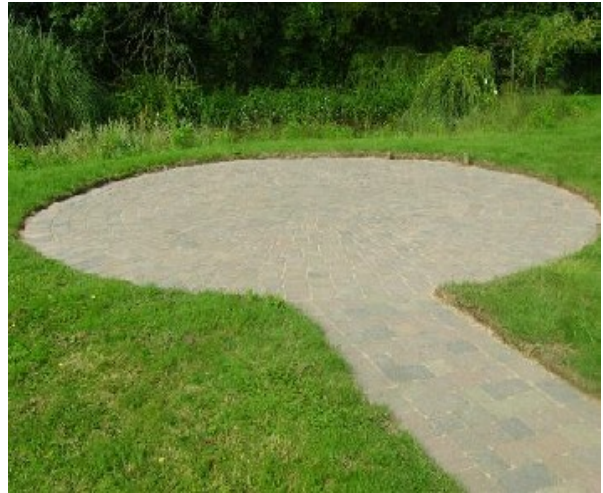
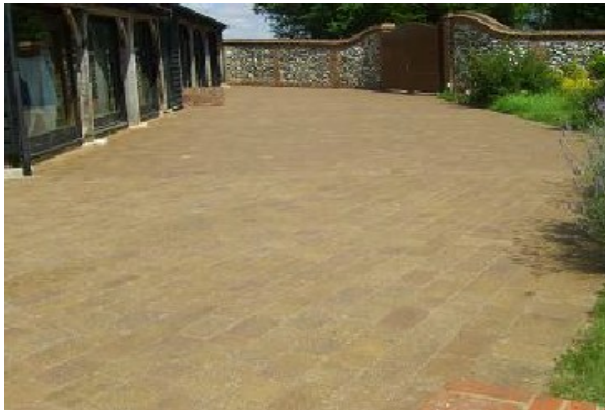
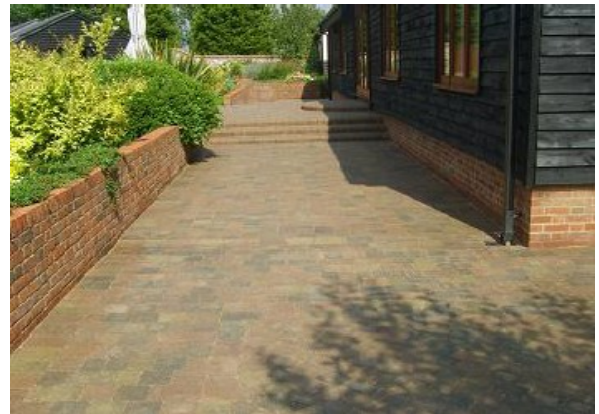
## Finished job Gallery

The photographs in the finished job gallery which follow, show what a difference our services can make to the appearance and usability of a property. The benefits are truly amazing!

A further delay was incurred until the weather forecast indicated a period of stable fine weather. This was necessary, because the weather is critical to sealing and we could not risk a failure with such a large area to seal. For convenience, the large quantity of sealant & jointing sand required was delivered directly from the suppliers to the client's home, as he had agreed to store it in his garage. To carry out the actual sealing we used a 4-person team on the first day and a 3-person team on the second. This enabled us to complete the re-sanding and sealing in two days, some 56 person-hours of work.

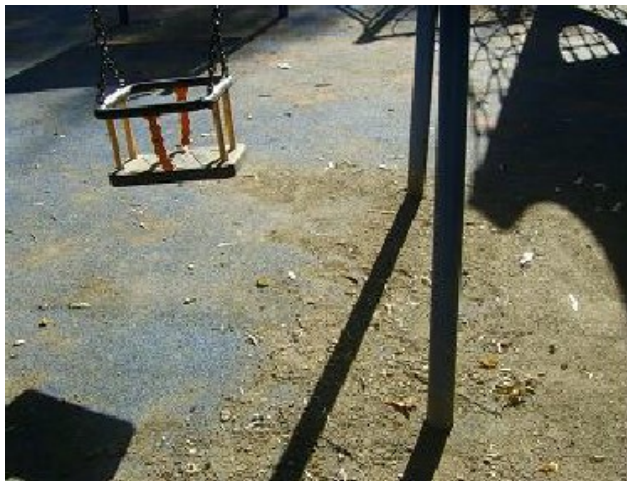
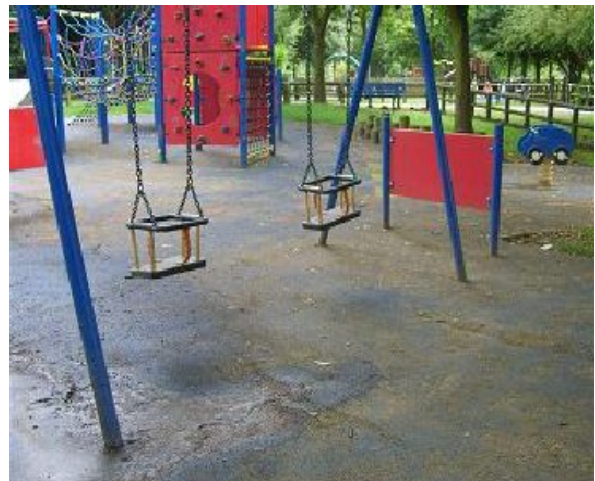
### **Example pictures of flood damage**

During the floods of the summer 2007, the park near the river Great Ouse that passes through Buckingham became flooded. After these floods had drained away it left the children's play areas contaminated with dirt, silt from the riverbed, sewage and other pollutants from the drains with a really bad smell rendering the play areas unsafe to use. There was an obvious need for the services of Jet Stream Drive Clean, so we approached the Town Council with some proposals to clean up these areas, after which they invited us to submit a written quotation.

After the Town Council had liaised with their insurers Jet Stream Drive Clean were given the go ahead to carry out their proposed cleaning programme so that the play grounds could be reopened to the general public again. The pressure washing was carried out over a 4-day period, after which we then had to treat the cleaned areas with a Sanitizer. The treatment of the cleaned areas with the Sanitizer was deemed necessary to kill off any remaining bacteria, viruses, and fungi. The application of this is explained in the section Chemical Treatments , which contains additional examples of the flood story. The application of the Sanitizer involves simply pouring the ready-to-use product into our backpack sprayer and spraying it over the affected areas. This sanitisation process took a further half a day to complete.
